# Manhole Inspection Summary

Manhole # S13II\_007MH

**Location** Address: **REAR 1712 DUKELAND ST** Cross Street: **PRESBURY ST**

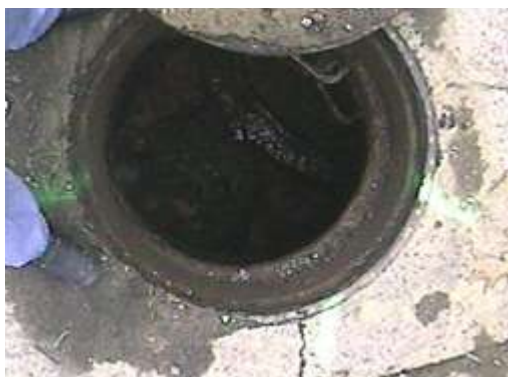
Defect 2

**Frame** Offset: **2** (in.) Condition: ☒ Sound ☐ Cracked ☐ Leaks

frame offset

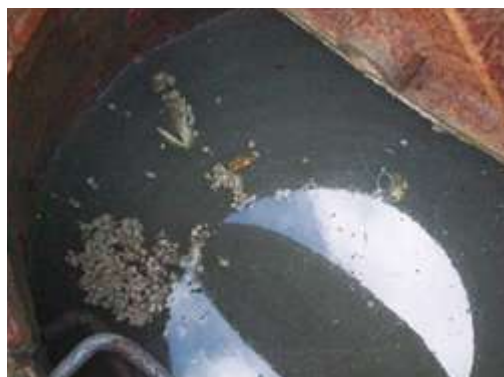
Defect 1

**Surcharge** ☐ Evidence Of Surcharge Depth: (ft.) ☒ **Active Surcharge Present**

ASUR

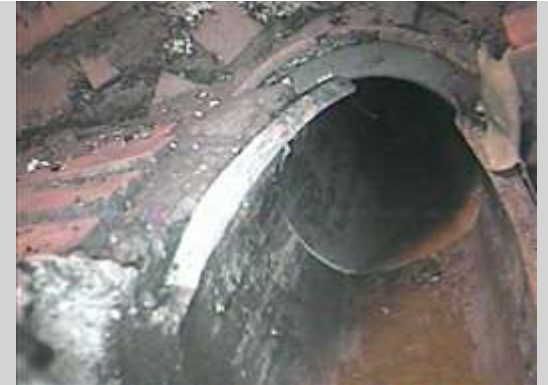
12 O'Clock Outflow

8 in. Circular Gravity Sewer  
Pipe Out @ 12 O'Clock

Pipe Height: (in.) Direct  
Pipe Material: **Clay** ☐ Pipe Lined  
Invert Depth: **6.83** (ft.) Flow Characteristics: **Slow**  
Deposits: ☒ None ☐ Mud ☐ Sludge ☐ Debris ☐ Grease  
Silt Depth: (in.) Deposits Extent:  
Infiltration: **None** Pipe Seal Cond: **Sound**

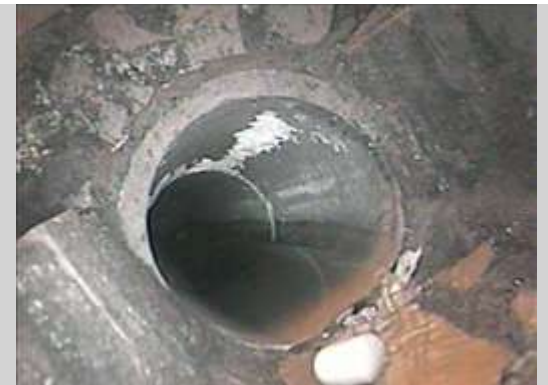
3 O'Clock Inflow

8 in. Circular Gravity Sewer  
Pipe In @ 3 O'Clock

Pipe Height: (in.) Direct  
Pipe Material: **Clay** ☐ Pipe Lined  
Invert Depth: **6.82** (ft.) Flow Characteristics: **Slow**  
Deposits: ☒ None ☐ Mud ☐ Sludge ☐ Debris ☐ Grease  
Silt Depth: (in.) Deposits Extent:  
Infiltration: **None** Pipe Seal Cond: **Sound**

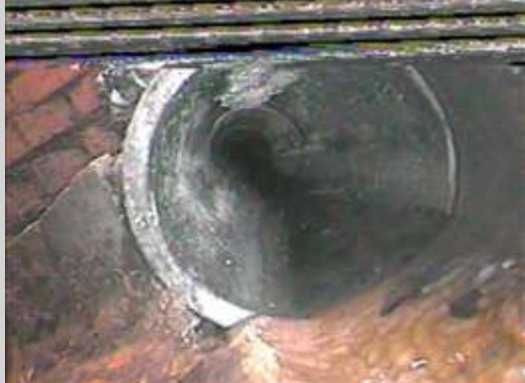
6 O'Clock Inflow

Invert Depth: **6.82** (ft.) Flow Characteristics: **Slow**

Infiltration: **None** Pipe Seal Cond: **Sound**

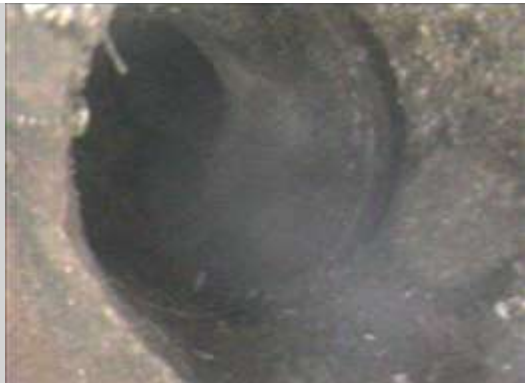
9 O'Clock Inflow

Invert Depth: **6.80** (ft.) Flow Characteristics: **Slow**

Infiltration: **None** Pipe Seal Cond: **Sound**

Connects To: **House connection / Service line**
